# Structural behavior of reinforced concrete beams incorporating cocopeat as a partial sand replacement

This study investigated the reinforced concrete beams' structural behavior when the sand aggregate is partially replaced with coconut peat also known as cocopeat. The concrete mixes were prepared by 0, 20, 50 and 100 % variation levels of replacement. Flexural loading tests were conducted on the reinforced concrete beams by also considering the variations in stirrup spacing and main bar diameters. The results indicated that, replacement up to 20 % of sand with hardened cocopeat maintained acceptable structural performance with those with 20 % replacement presented a comparable load bearing capacity and crack resistance to control specimen. Greater than 20 % replacement level exhibited significant reduction in strength and stiffness. The results also revealed that closer stirrup spacing, and larger diameter steel bars overcome the limitations of cocopeat content, improving the beam performance. The study supports the potential use of cocopeat as partial sand replacement in sustainable concrete construction.

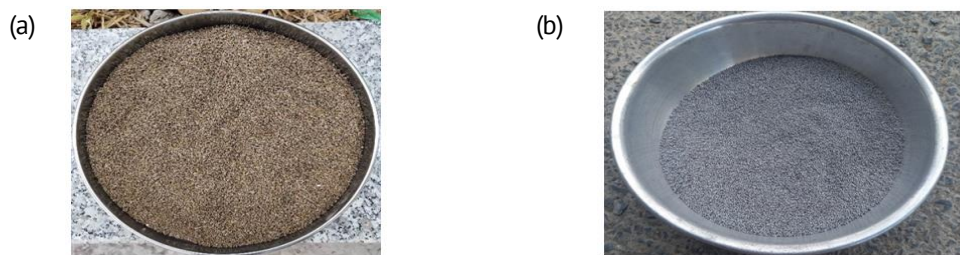
Step 6: the mixture is allowed to solidify for 24 h. Then, the hardened particles are sieved. The final product consisted of particles that pass through the 2.5 mm sieve and retained by the 0.63 mm sieve (Fig. 6).

**Fig. 6.** Cocopeat hardened with cement: (a) finished product remaining on 0.63 mm sieve, (b) finished cocopeat granules have been hardened with cement

This study shows that the “cocopeat particle hardening method” using cement (Fig. 6), following the cocopeat production process described in the one of the previous sections, and the sand / cocopeat ratio (Table 2) have improved the performance of these reinforced concrete beams.

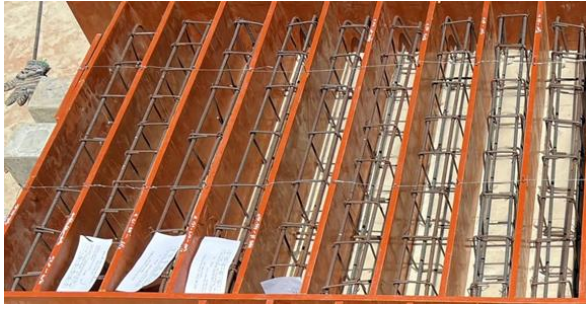
**Fig. 8.** Formwork and reinforcement processing

The steel reinforcement for the beams was processed according to the specifications outlined in Table 2 and depicted in Fig. 8. After the reinforcement was properly placed and secured, formwork was installed to shape the beams. Once the reinforcement and formwork were ready, concrete was poured into the forms to create the reinforced concrete beams, as shown in Fig. 9.

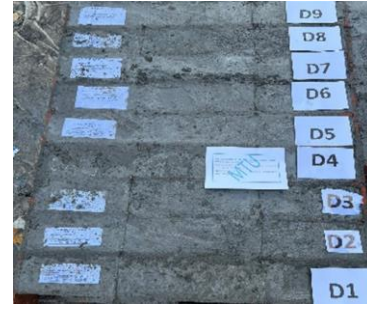
**Fig. 9.** Reinforced concrete beams

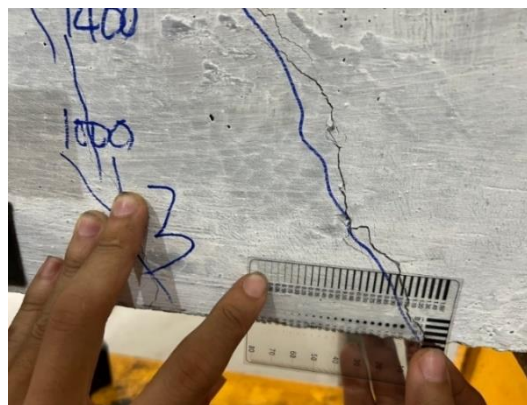
The test results indicate that all reinforced concrete beams, from Beam D1 to Beam D8, initiated their first cracks under a load of  $P = 700$  Psi (equivalent to 35 kN). In contrast, Beam D9 exhibited its initial crack at a higher load of  $P = 1000$  Psi (equivalent to 50 kN), as demonstrated in Figs. 28 and 29. These observations are consistent with prior research on crack formation and propagation in reinforced concrete beams subjected to short-term loads [42], as well as studies on deflection and cracking in flexural concrete beams [43]. The cracks predominantly appear at the center of the beam and near the points of force application, with vertical cracks developing in the middle of the beam and diagonal cracks forming at 45 degrees in the support areas. As the load intensifies, both the length and width of these cracks increase, as depicted in Fig. 30. Specifically, at a load of 35 kN, the crack width measures 0.02 mm, which expands to 0.70 mm at a load level of 125 kN, as illustrated in Figs. 30 and 31.

**Fig. 31.** Measure the crack width of D8 reinforced concrete beam
